INTERIM REPORT

TS-PIC-20305593S
MARCH 2003

INTERIM AERIAL PHOTOGRAPHIC ANALYSIS OF
N-FORCER SITE

Dearborn, Michigan

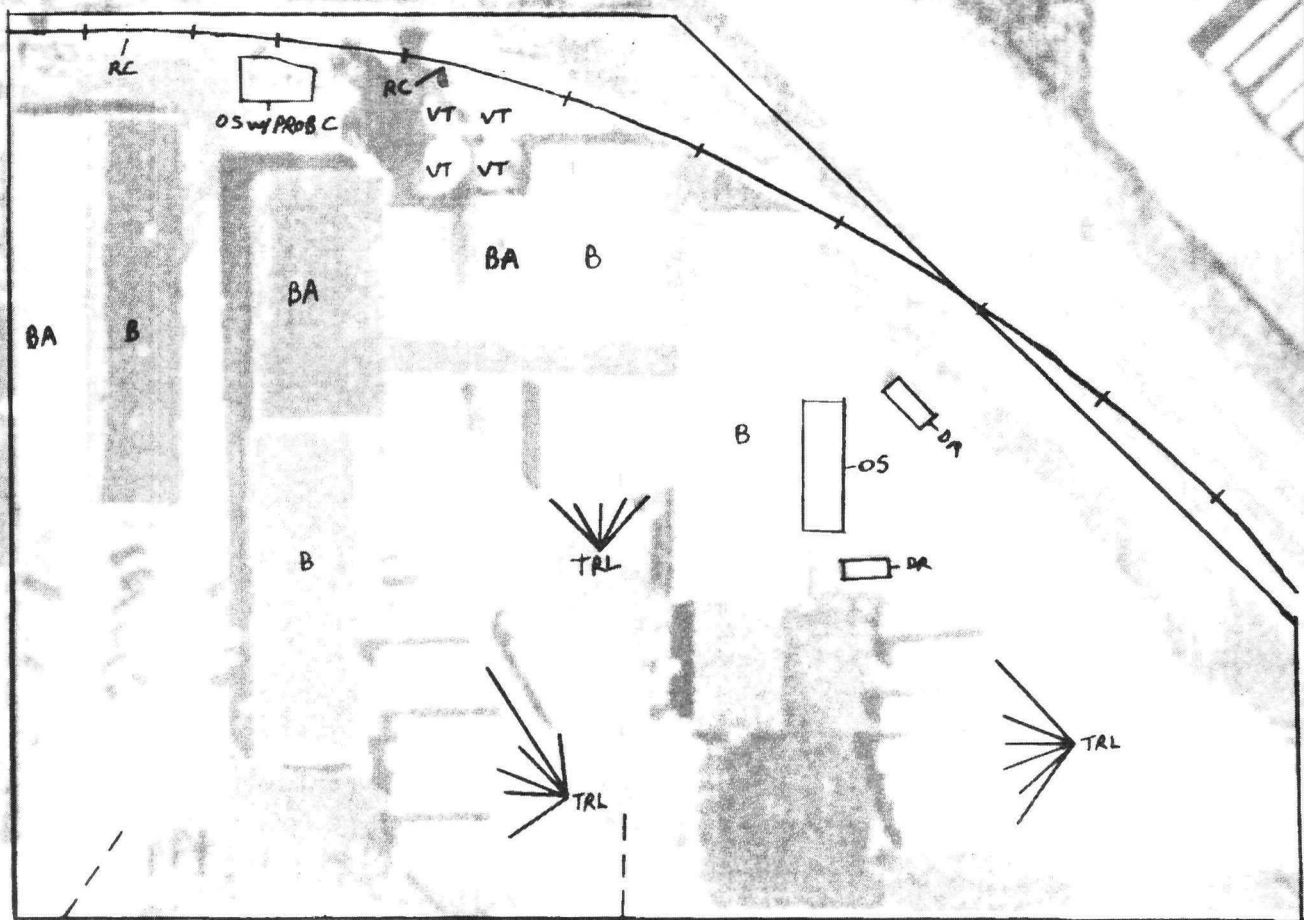
APRIL 18, 1990

Two building additions have been constructed on the production facility; one south of the vertical tanks and one linking the western end of the production facility to another, formerly freestanding building. A building addition has also been constructed on the west side of the building in the western portion of the site.

An open storage area with possible containers (C) is visible to the northwest of the production facility. An open storage area containing unidentified objects (not annotated) is seen adjacent to the eastern side of the production facility. Two dumpsters are present east of the production facility.

Six trailers are visible to the southeast of the production facility. A group of five trailers are observed on the parking lot adjacent to the south side of the production facility and six trailers are visible to their south.

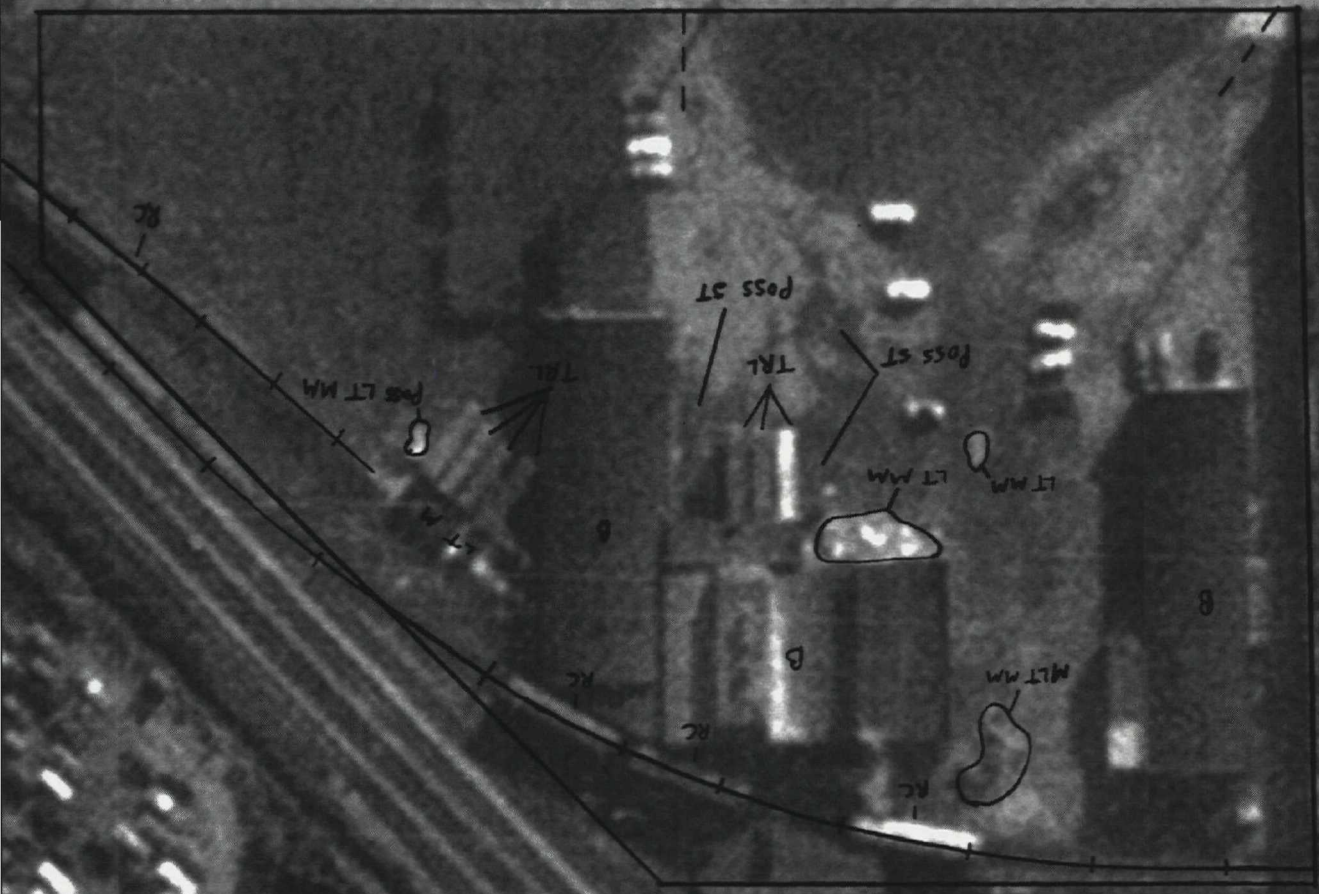
NOVEMBER 21, 1966

Light-toned mounded material is seen adjacent to the southwestern side of the production facility, where light-toned material was previously noted on the 1951 photograph. Further to the southwest, a smaller area of light-toned mounded material is present. Light-toned material and possible (POSS) light-toned mounded material are noted to the east of the production facility. Multi-toned (MLT) mounded material is visible to the west of the production facility.

Three trailers and two areas of possible staining are seen on the parking lot south of the production facility. Four trailers are present east of the production facility. The disturbed ground noted west and southwest of the production facility on the 1951 photograph is no longer observed and portions of this area are now used for vehicle parking.

Four railcars are visible on the rail spurs.
